I Inspec Homes

PROPERTY INSPECTION REPORT

Report Identification: 20131	1204-01, , , TX	
------------------------------	-----------------	--

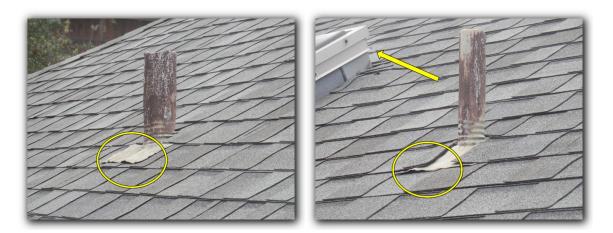
- ✓ Flashing is lifting, ill configured, or missing
- ✓ Leaves / debris in the gutters and downspouts
- ✓ Tree branches are too close to the roof structure

I would recommend to have all flashing caulked around all opening on the roof to help prevent damage.

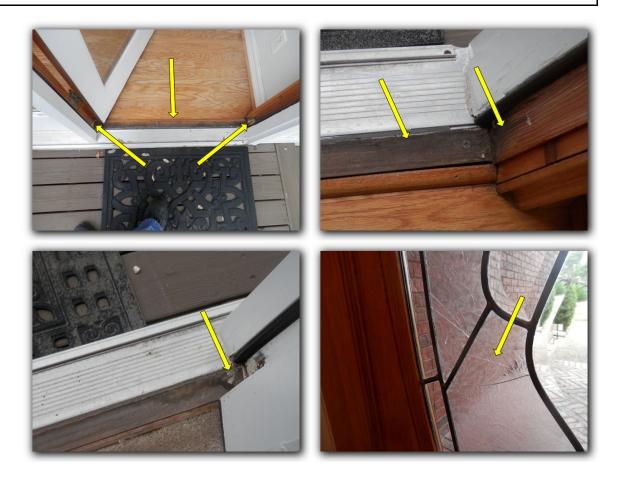
Type: ☐ Metal ☐ Wood ☑ Fiberglass ☐ Doors / panels are damaged At the time of inspection there was a broken glass pane that needs to be repaired

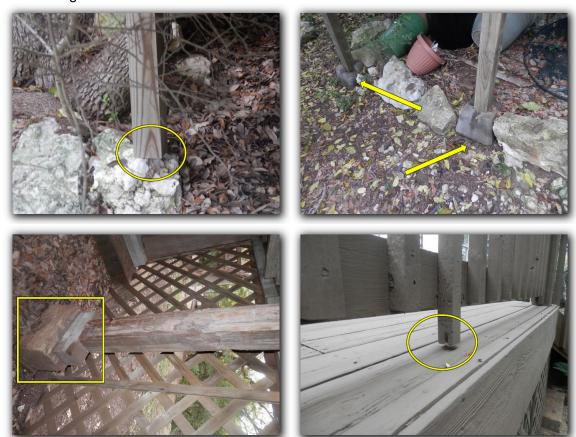
At the time of inspection the 1st deck that's connected to the back of the house should have the posts connected to the footings and the deck its self would recommend to have a licensed contractor to repair. The deck its self is sagging in certain areas due to wood rot that needs to be repaired by licensed contractor to prevent further damage or a hazard.

The 2nd deck on the left side of the house behind breakfast area requires rail if the deck is over 30" from the ground to prevent a hazard. There was signs of wood rot that needs to be repaired or replaced by a licensed contractor.

The 3rd deck furthest away from the house requires no openings around the railings to not exceeding 4" which had an opening of 5" that should be repaired to prevent a hazard. There was not enough support with the floor joists which I would recommend to improve or repair to prevent a hazard. The footings for the deck is not supported very well would recommend to have a licensed contractor evaluate to prevent from footing from sliding out from the deck.
